# Visualization of Crystalline Defects in Silicon, a Cause of Electrical Leakage in Semiconductor Devices

S. Y. Chow, S. L. Lee, K. Y. Lim, B. S. Khoo, C. Fu and X. M. Li

WinTech Nano-Technology Services Pte. Ltd.

**Abstract – Detection of electrical leakage in semiconductor devices indicates presence of electrical paths between junctions of p-doped and n-doped silicon, if no other physical abnormality is observed. This paper describes the use of advanced failure analysis tools to precisely locate and visualize crystalline defects in silicon that have caused electrical failure.**

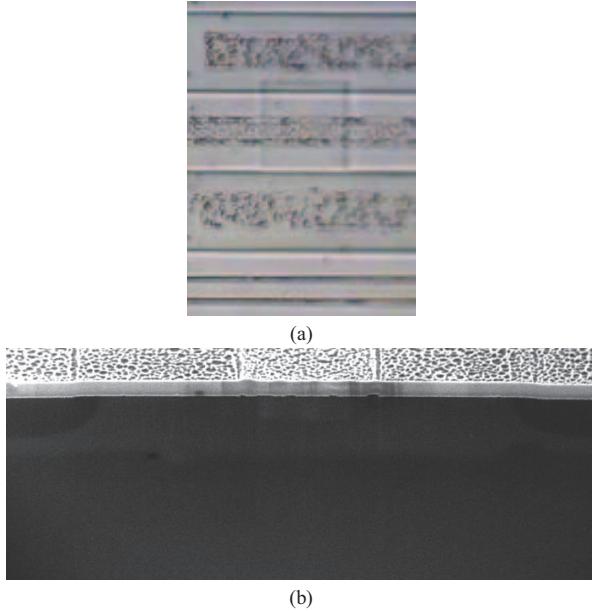
A square underlying feature beneath the silicon surface was observed at defective site as shown in Fig. 1(a). Focused ion beam (FIB) milling across two parallel edges of the underlying square reveals cross-section of the defective site. Abnormal base profile of well was observed, showing a wavy dopant distribution profile, as shown in Fig. 1(b). The unusual base profile of well, however do not infer presence of electrical leakage path across the p-n junction. Cross-sectional TEM sample was prepared by using FEI Helios NanoLab 600i DualBeam across one of the remaining edges of the same underlying square, across unusual base profile of well.

Fig. 1(a) Optical image of de-layered sample, a square feature underneath silicon surface was observed. (b) FIB cross-section image showing unusual base profile of well.

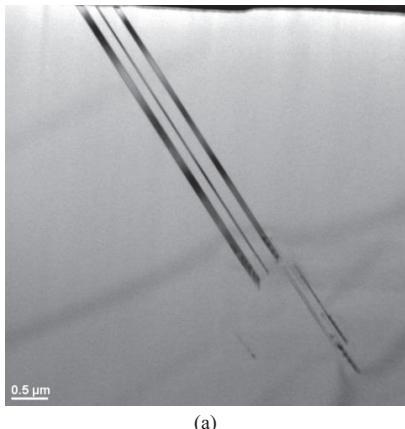
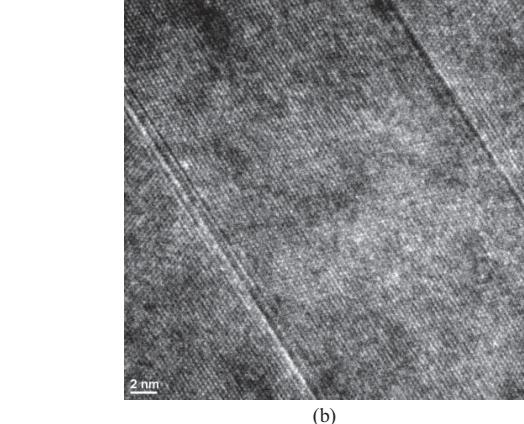
There are obvious substrate dislocations at region of closed proximity to one of the edges of underlying square, at electrically failed site. The longest and deepest dislocation as observed in TEM image Fig. 2(a) has depth 4.8  $\mu\text{m}$  from the substrate surface. High resolution TEM image shows regions of silicon having different crystalline orientation from bulk silicon (stacking fault), as shown in Fig. 2(b). Since depth of

source/drain, as measured from the FIB cross-sectional image is  $2.4 \mu\text{m}$ , the deepest reaching dislocation observed is long enough to span across p-n junction, forming leakage path across the source/drain and the well.

Fig. 2(a) TEM image shows substrate dislocations. (b) High resolution TEM image shows regions of different crystalline orientation.

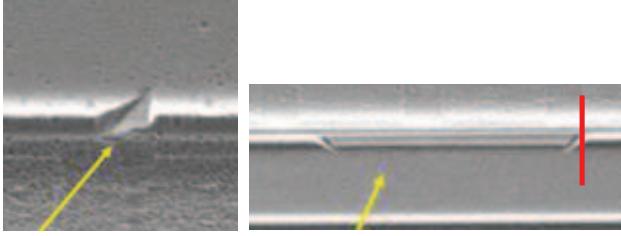
Chemical delineation etching was performed on de-layered silicon-remaining only sample in another case. Two kinds of distinctive etch pits, triangular etch pits, and sink-in surfaces were observed on surface of the etched sample, as shown in Fig. 3. We believe these surface morphologies attribute to crystalline defect of different nature. A cross-sectional TEM sample was prepared across one of the edges of the sink-in surface. No substrate dislocation was found from TEM image. It is postulated that crystalline defect may have been completely etched during the chemical delineation etching, since precise control of etching time for crystalline defect of unknown depth is challenging, leaving behind only perfect silicon crystal.

Fig. 3 Two kinds of etch pits observed on surface of silicon substrate after Secco etching. No crystalline defect was observed in cross-sectional TEM sample prepared at location indicated by red line of the etched sample.

It is postulated that crystalline defect that results in sink-in surface etched region, as shown in Fig. 3, comprises of silicon of different crystal orientation at sink-in and non-sink-in region. Schematically, bright field TEM image of the same type of un-etched crystalline defect would appear as Fig. 6, being each side of diffraction contrast (bright and dark sides) representing one crystal orientation.

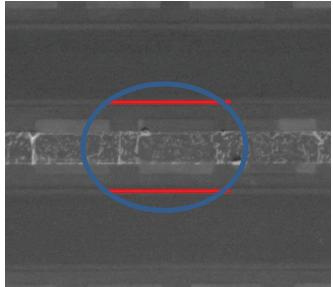
To exactly clarify electrical failure mechanism, another defective sample, de-layered silicon remaining only sample, of the same device, was not subjected to chemical delineation etching. Defective region was identified by overlaying of circuitry and emission spot image. Two cross-sectional TEM samples were prepared along adjacent p-n junctions at region encompassed by the emission hot spot, as shown in Fig. 4. No crystalline defect was observed from one of the cross-sectional TEM samples prepared. Substrate crystalline defect, of depth about  $3.2 \mu\text{m}$ , was observed in the other cross-sectional TEM sample prepared, as shown in Fig. 5(a). Since the cross-sectional TEM sample was prepared along a p-n junction, also consider that the TEM lamella has a thickness of about  $80 \text{ nm}$ , chances of crystalline defect observed to span across p-n junction, causing electrical failure is high. Zoom-in image at the tip of defect shows stacking faults, as shown in Fig. 5(b).

Fig. 4 Top-view image at defective site. Electrical hot spot was observed at region encompassed by the blue oval shape. Two cross-sectional TEM samples were prepared along adjacent p-n junction interfaces, as indicated by red lines.

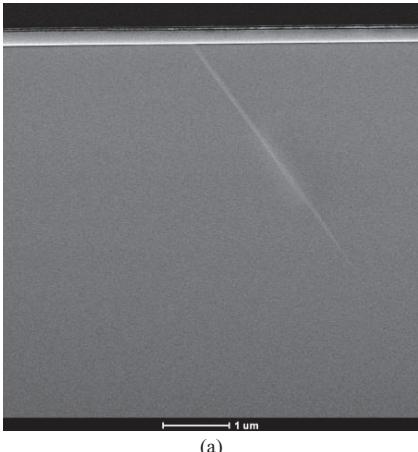
Fig. 5 (a) STEM image of cross-sectional TEM samples prepared along one of the p-n junction interfaces, showing dislocation. (b) Zoom-in TEM image at tip of the same defect.

Crystalline defect observed in TEM sample without undergoing chemical delineation etching is correlated with etch pits observed in chemically etched sample. It is postulated that crystalline defect as observed in Fig. 5 would appear as triangular etch pit should the sample has undergone chemical etching. Width and depth of the triangular etch pit as observed in Fig. 3, is similar to the projected width from defect tip and the depth of crystalline defect observed in TEM image Fig. 5(a). The triangular etch pit spans across only one p-n junction, a likely explanation for absence of crystalline defect in cross-sectional TEM sample prepared along the other p-n junction.
